MICROSTRUCTURAL CHARACTERIZATION OF PRIMARY WATER STRESS-CORROSION CRACKS IN ALLOY 182 WELDS FROM PWR COMPONENTS AND LABORATORY TESTS

L.E. Thomas, M.J. Olszta, B.R. Johnson and S.M. Bruemmer

Pacific Northwest National Laboratory, PO Box 999, Richland, WA, 99354, larry.thomas@pnl.gov

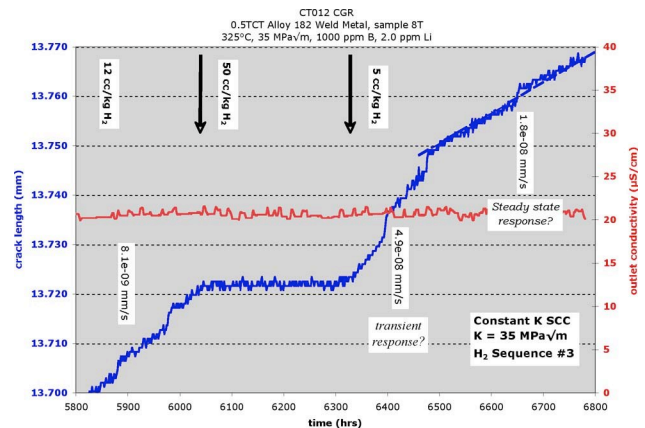
This particular test involved multiple sequences at different hydrogen levels spanning the Ni/NiO stability regime. A detailed description of the test has been published previously.⁹ The final test sequence over the last 0.05 mm (50 μm) of crack length was run at 5 cc/kg H₂ in the NiO stability ECP region near the Ni/NiO stability transition. This condition coincided with the highest measured propagation rates. Data from this part of the test are reproduced in Figure 2. The TEM examinations focused on the deepest cracks in this cross-section, corresponding to the last region of SCC growth.

Figure 2. Crack-growth data for alloy 182 weld in simulated PWR primary water at 325°C. End-of-test sequence at 5 cc/kg H₂, near the Ni/NiO stability transition.

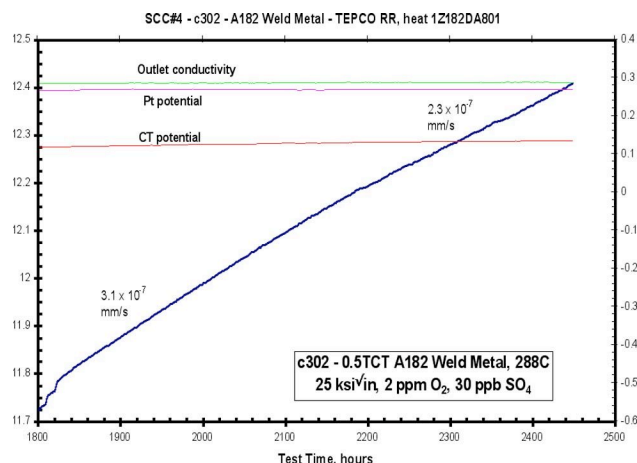
During the last ~1000 hours of the test, 30 ppb SO₄²⁻ was introduced (as H₂SO₄) to promote rapid crack growth. The last ~0.7 mm of cracking was obtained under constant K conditions. Figure 3 shows the well-behaved crack growth at the end of the test, which corresponded to the sample region that was examined by TEM.

Figure 3. SCC response of Alloy 182 weld metal tested in 288°C water containing 2 ppm O₂ plus sulfate.
